Application Of LUBRICLEAN EP & Changeover to GEARFLUID 550

in Pellet secondary ball mill open gear drive
On 27th June 2018

Pellet Plant
JAYASWAL NECO INDUSTRIES Ltd.
Siltara, Raipur(C.G.)

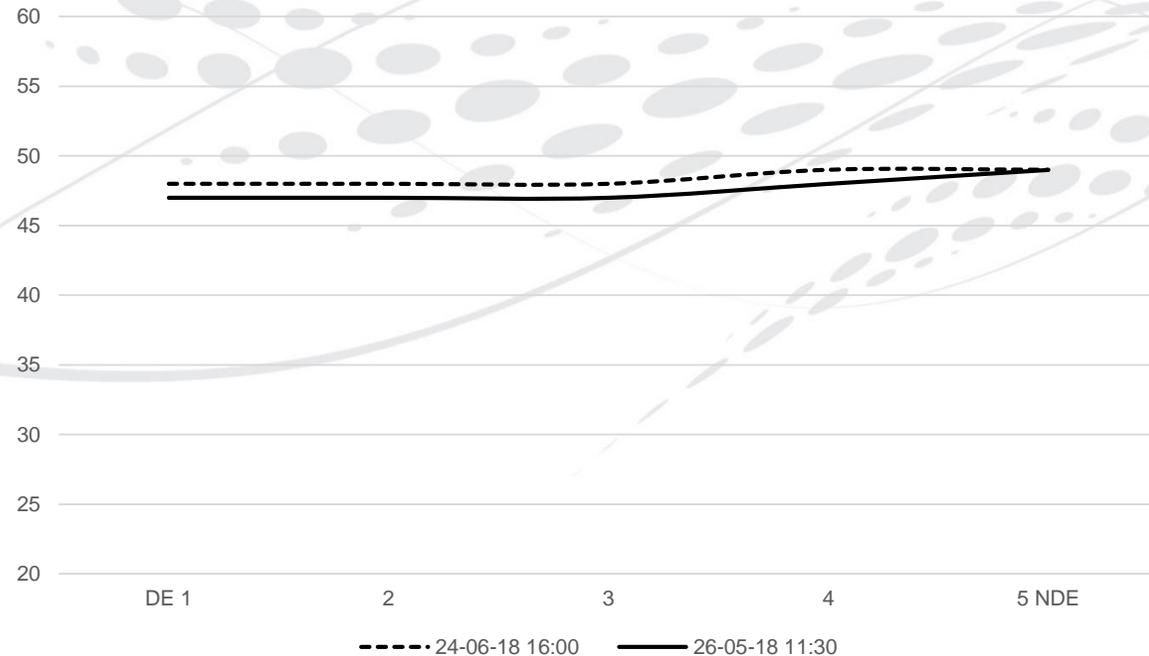
BEFORE TRIAL TEMPERATURE PROFILE

Date & Time	DE 1	2	3	4	5 NDE	ΔT	Amb. Temp.	Shell Temp
24-06-18 16:00	48	48	48	49	49	2	38	39
26-06-18 11:30	47	47	47	48	49	3	38	40

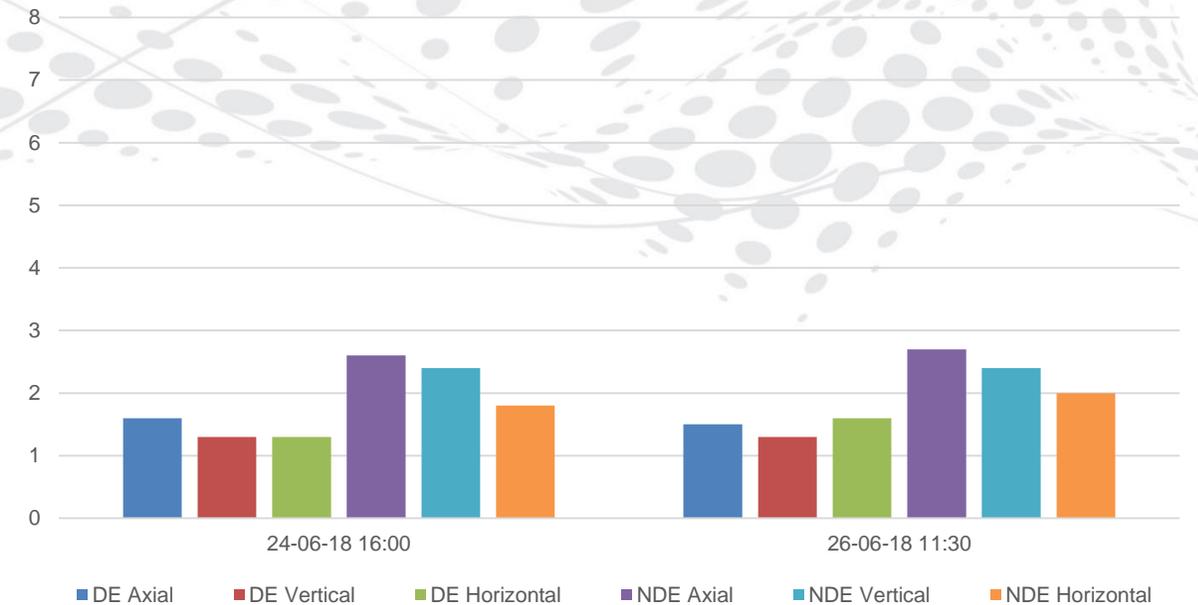
BEFORE TRIAL VIBRATION READINGS

Date & Time	DE (A)	DE(V)	DE(H)	NDE(A)	NDE(V)	NDE(H)
24-06-18 16:00	1.6	1.3	1.3	2.6	2.4	1.8
26-06-18 11:30	1.5	1.3	1.6	2.7	2.4	2.0

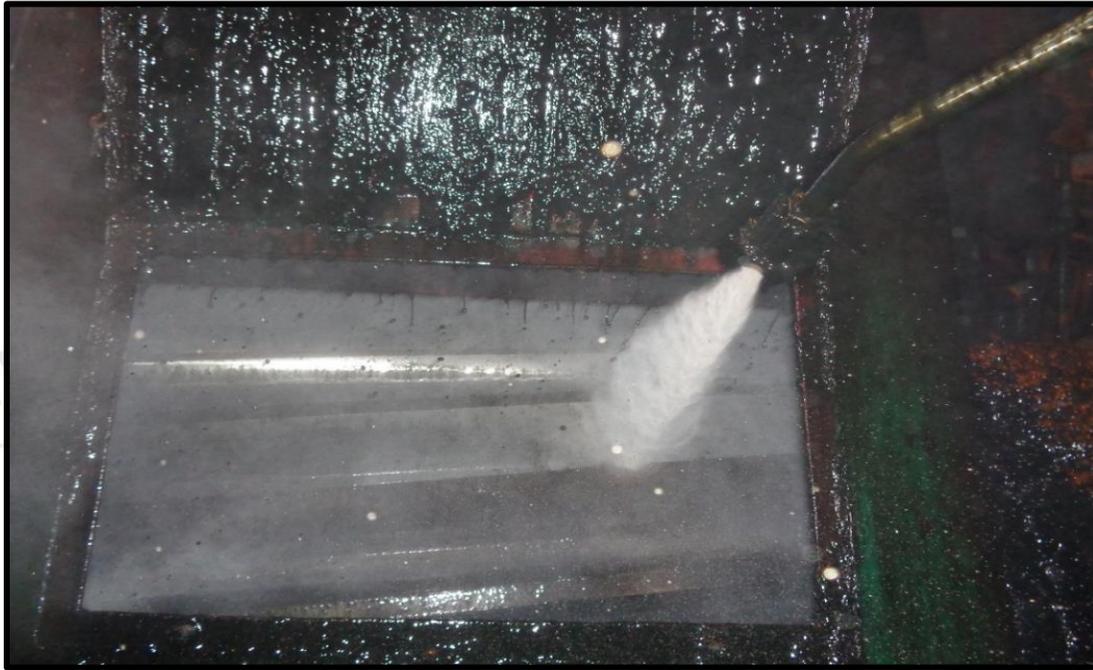
During Cleaning Operations, the jet of Lubriclean EP was directed towards the Pinion, Girth Gear as well as the junction of both depending on visual inspection with respect to the adversity of contamination.

Also during cleaning the flank temperatures were continuously monitored keeping in mind the safety of the gear drive.

The drainage of Lubriclean EP was taken care to maintain system cleanliness. The discharge was 16 litres/minute. The Cleaning operation took 40 minutes and an additional 60 minutes were taken for documentation and priming.

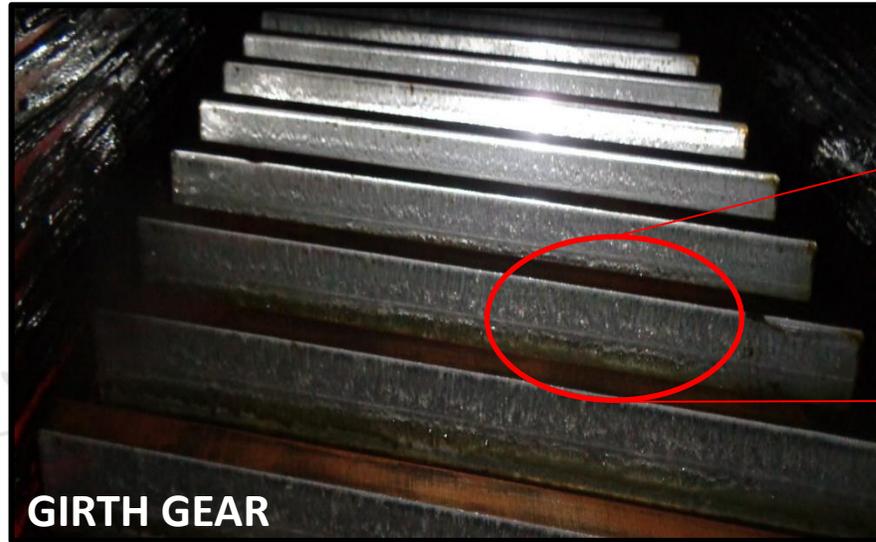
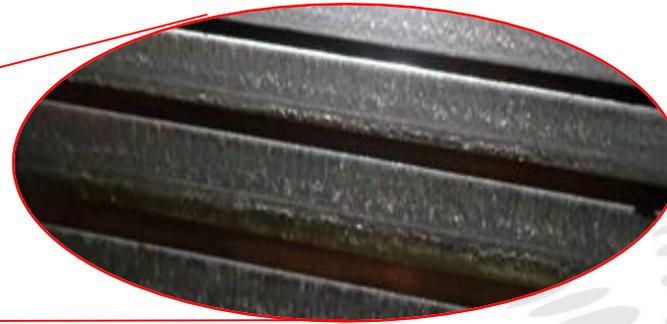
The picture on the left shows the girth gear after cleaning. As seen in the picture, numerous micro pittings were observed on the girth gear flank along with a few large pittings.

1. With reference to the inspection, the parameters were found to be stabilizing in nature. So you may continue to run your gear drive at the present consumption safely.
2. During the next shut down we will grind the large pittings with a high speed grinding burr and for the micro pittings to be polished it is recommended to run your drive with our running in lubricant for at least 200 hours.

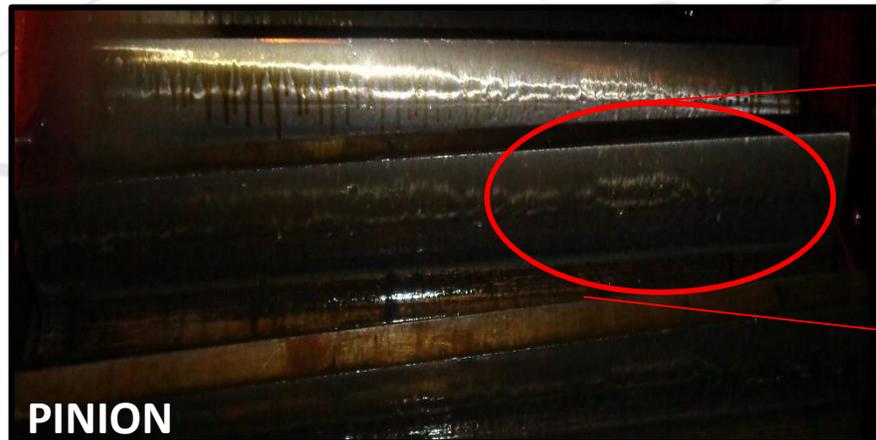
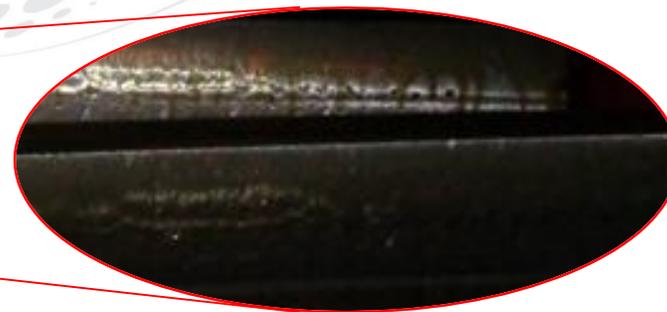
The picture on the left shows the pinion flank surface after successful cleaning.

We can see the formation of ridges across the pitch line as well as a few pittings were also observed towards the NDE side.

Few pittings are of propagating nature.

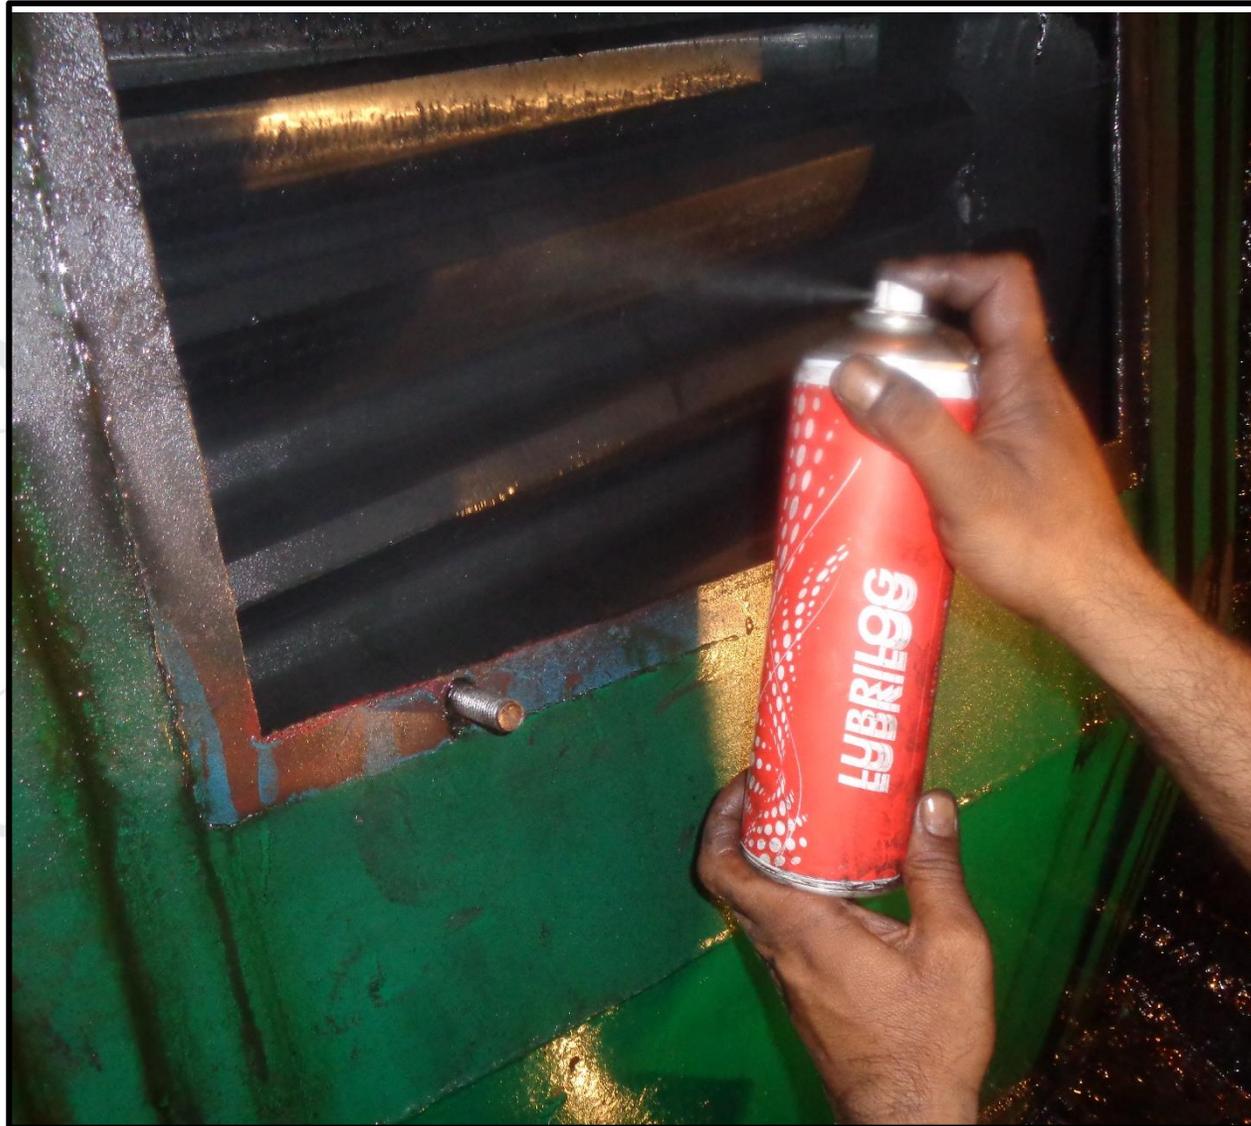
Priming is an integral part post cleaning operation. as the existing lubricant washes off after cleaning hence priming is essential to avoid dry running.

In this case priming was done by **GRAFLOG H1 SPRAY** in 500 ml aerosol cans. which ensures better coverage as well as reduces waste.

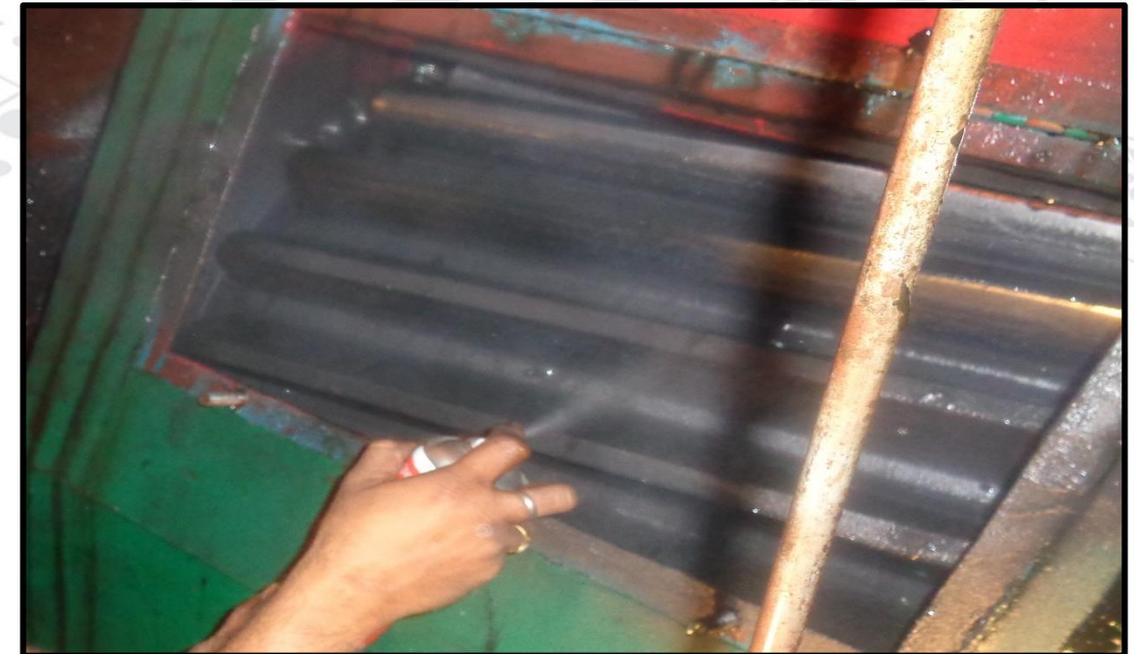
AFTER PRIMING operational Lubricant Switched Over to High viscosity transparent Lubricant

GEARFLUID 550 on 27th June 2018.

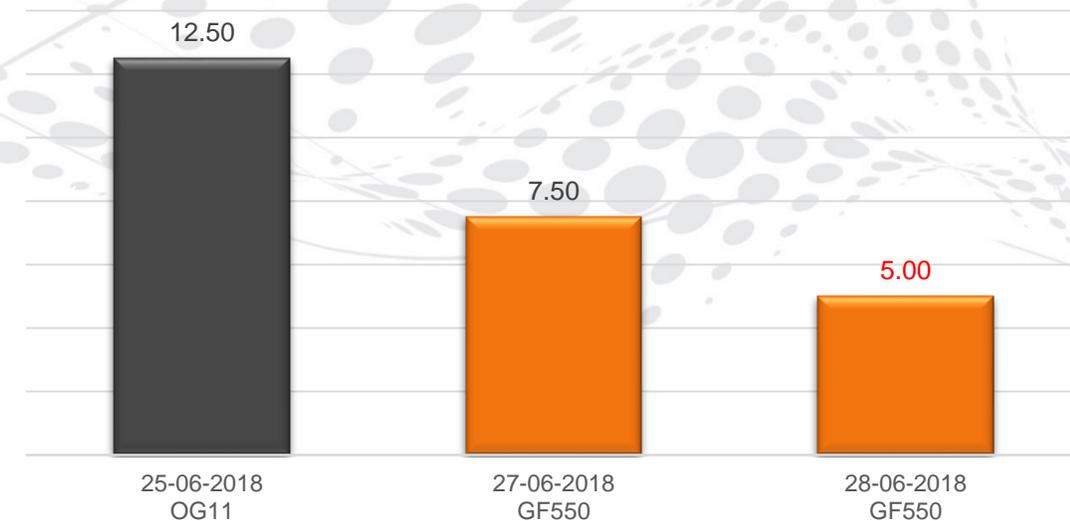
Consumption Optimisation (kg/day)

- High 4-ball weld load of 9800 N which ensures better protection
- Switching over to transparent fluid will reduce lubricant consumption by 60%. Hence reducing the disposal cost of waste lubricant.
- Nozzle choking will be avoided as GEARFLUID 550 contains no solid Graphite.
- Better visibility of the tooth flank surfaces of a gear drive.
- Fluid reduces the temperature gradient significantly. Hence reducing the power cost.
- The Present consumption is 5 Kg/day.

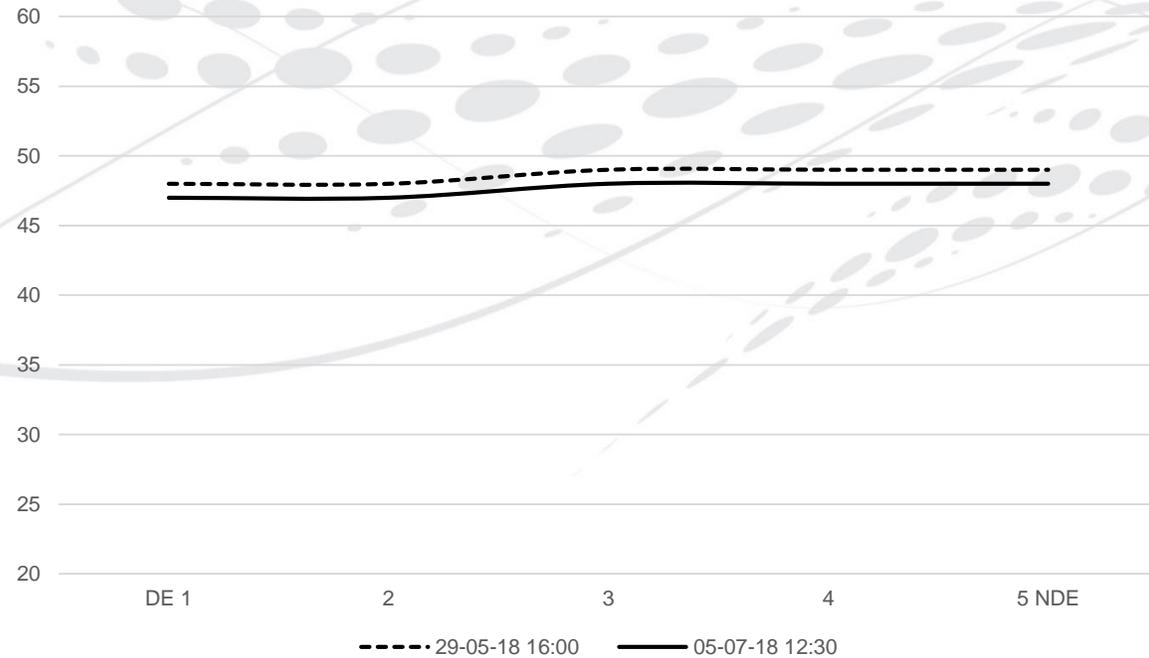
AFTER TRIAL TEMPERATURE PROFILE

Date & Time	DE 1	2	3	4	5 NDE	ΔT	Amb. Temp.	Shell Temp
29-0-18 16:00	48	48	49	49	49	1	32	36
05-07-18 12:30	47	47	48	48	48	1	32	39

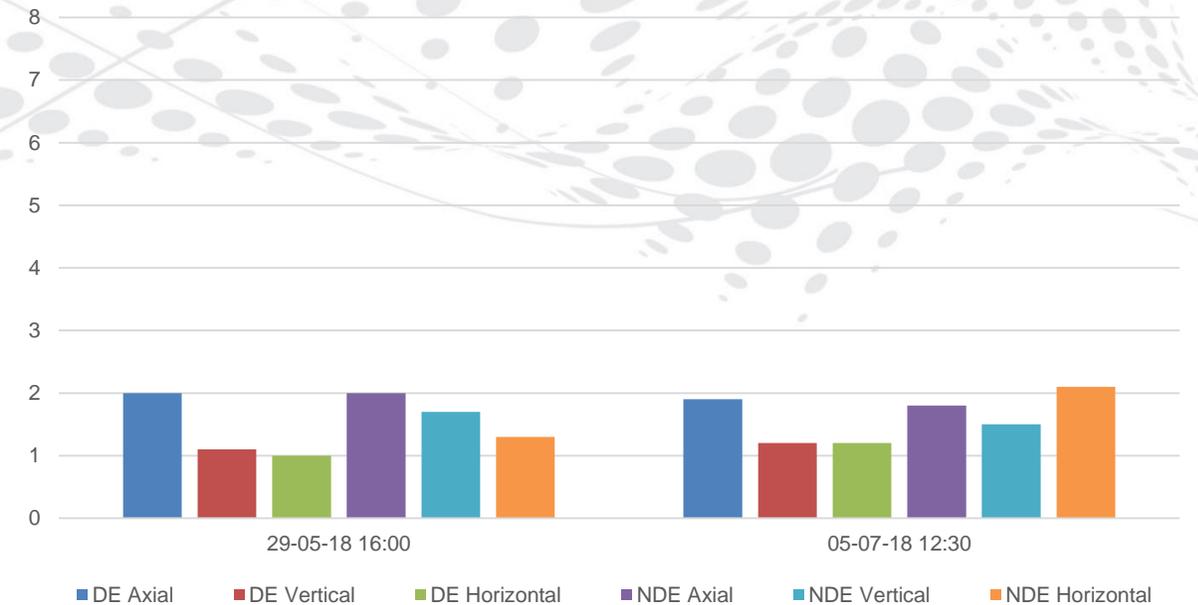
AFTER TRIAL VIBRATION READINGS

Date & Time	DE (A)	DE (V)	DE (H)	NDE (A)	NDE (V)	NDE (H)
29-06-18 16:00	2.0	1.1	1.0	2.0	1.7	1.3
05-07-18 12:30	1.9	1.2	1.2	1.8	1.5	2.1
